# ALL IN ONE - Maintenance and Repair Manual - Edition 1 and 2 Correction to the tightening torque when screwing the brake calliper

Edition 1 and 2 of the ALL IN ONE Maintenance and Repair Manual have an error occurred at specify brake calliper torque. This information must be corrected in the already handed over editions.

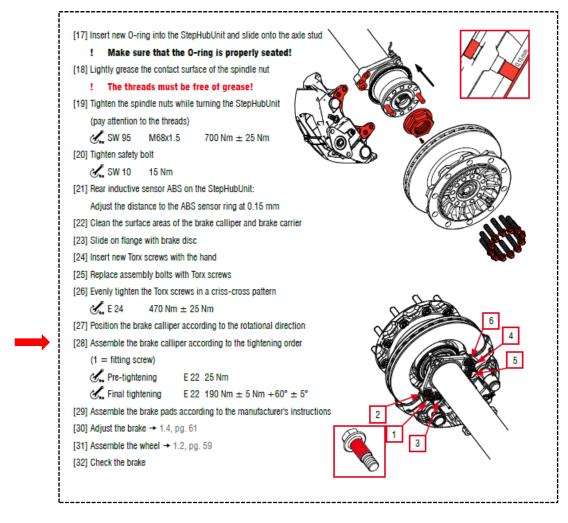
#### Error

Rotation angle 90° at step 28 on the above announced pages.

## **Correction:**

Rotation angle 60° is correct.
